Study Report:

Identification of spatial priorities for the re-opening of wetlands to maintain the water flow required for ecological functioning, biological connectivity and habitat maintenance.

Xe Champhone Ramsar Site, Lao PDR

CAWA Project, December 2017

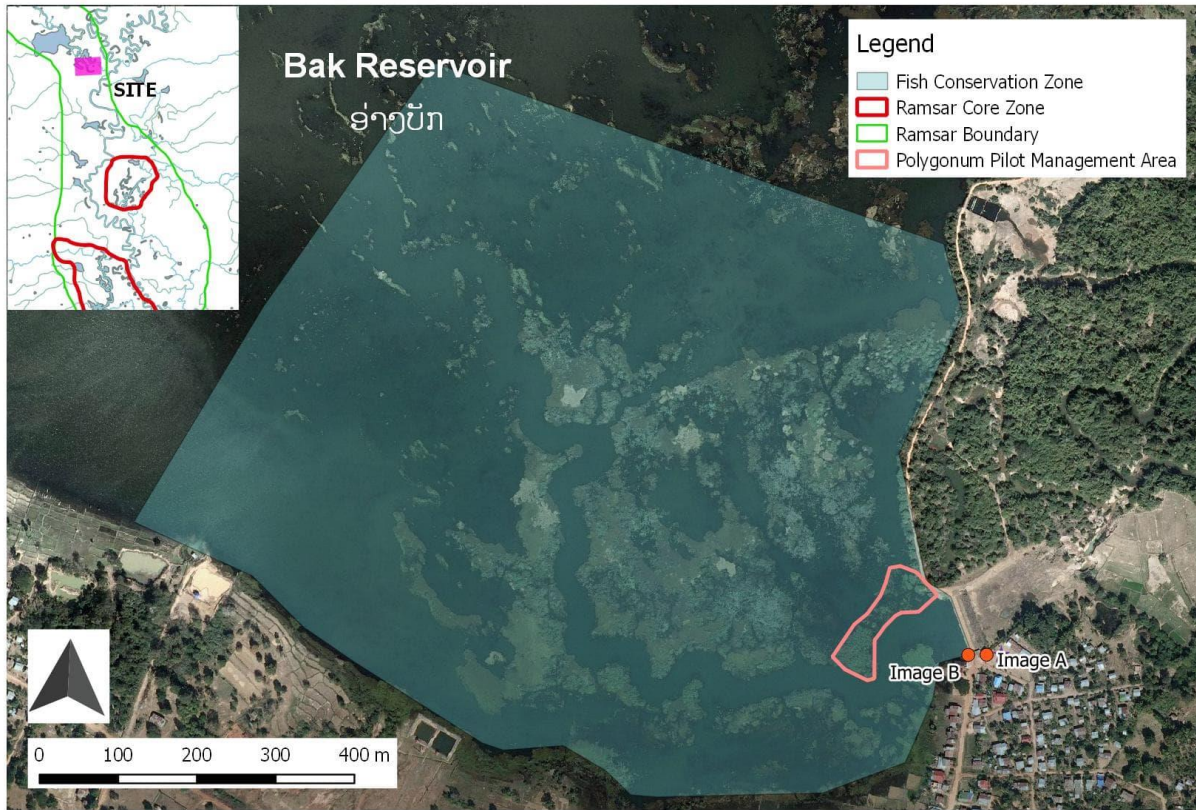
Figure 1. Site 1. Bak Reservoir - Fish Conservation Zone

Local villagers interviewed recommend that patches of Polygonum be assessed for management, with a focus on a ~60 by 100 metre area close to the dam on the northern side, the total area is 0.66 hectares (Figure 1). Feasibility of management is high, with good access to the site for removal and local villagers expressing a willingness to help with the removal of the plants. This will be treated as a small pilot management site initially, as it is a native species and its response needs to be monitored carefully.

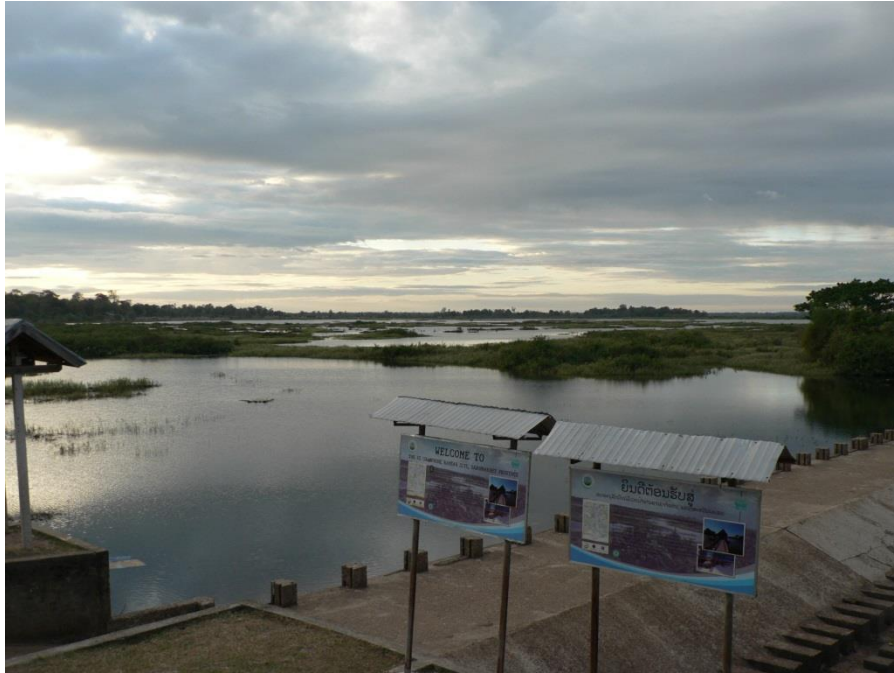
Image A. Looking over the reservoir, northwest towards the Polygonum

A native species *Polygonum tomentosum*, has recently expanded and is currently the main species of concern identified by communities, in a particular area of the FCZ, close to the village and dam weir. The reason for its expansion could be due to an extended dry period prior to 2017, as it prefers shallow water areas, and changed hydrology may be contributing to altered growth patterns (Haroon and Hussain, 2017). This species while native can become dense under certain conditions. While normally a native species wouldn't be targeted for removal, the concerns from the villagers deem it a priority to address.

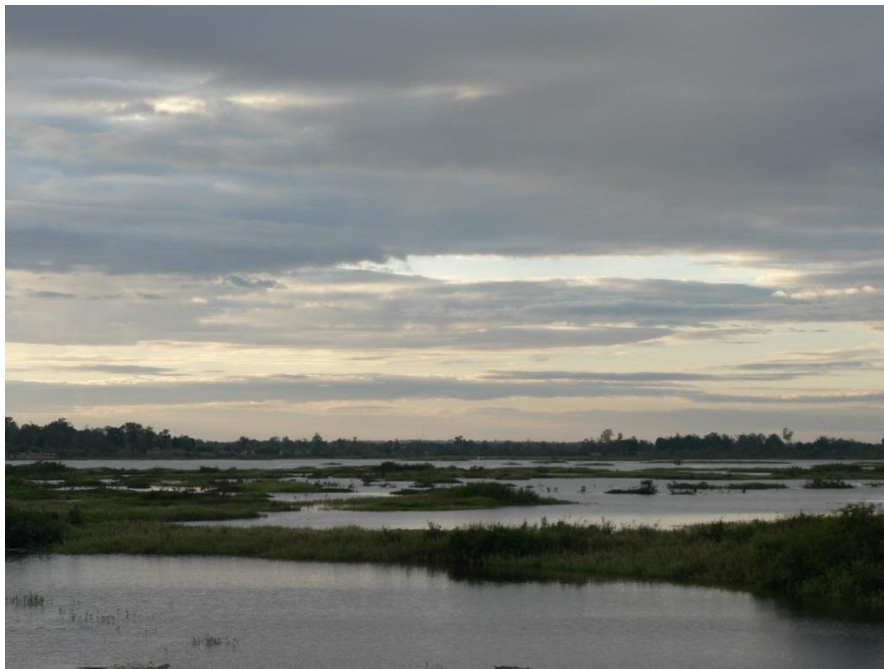
Image B. View of the central area of the Polygonum in the reservoir

Polygonum tomentosum is a native species, and as such management needs to be carefully monitored. Only small areas of removal within the 0.6 hectare area demarcated are recommended initially. Polygonum is a rooted aquatic species but removal by hand from boat is indicated as a potentially effective method to remove the entire plant (O.Thongsavath pers. com). Trials will be conducted as a first phase of the pilot in April 2018.

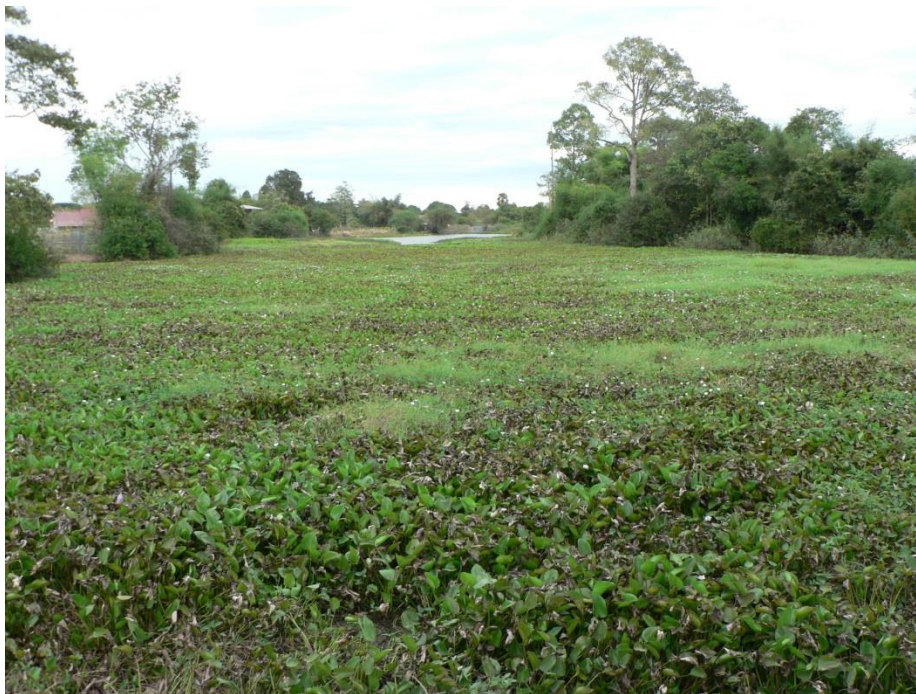
The site is densely covered by water hyacinth, and used to be largely open water. Villagers have observed reduced abundance of fish in June and July compared to the past, with fish movement restricted during the dry season. A local village woman interviewed believes water levels in the oxbow are lower due to sediment being trapped and the decomposition and build-up of water hyacinth plants. During the dry season the water depth is approximately 2 metres, while in previous years it was reported to be considerably deeper.

Image A. Northeast view of the water hyacinth infestation

For control of water hyacinth, as a free floating species, all villagers surveyed indicated that manual control by hand removal is the preferred control method and the one used for its removal in rice paddies. Villagers at Ban Taleo-Phonkho and Ban Kadan indicated that, men often work in the deeper water areas and women near the edge to pull up and remove the plants. It is anticipated this will be the best technique to recommend for water hyacinth control in this program as villagers are familiar with

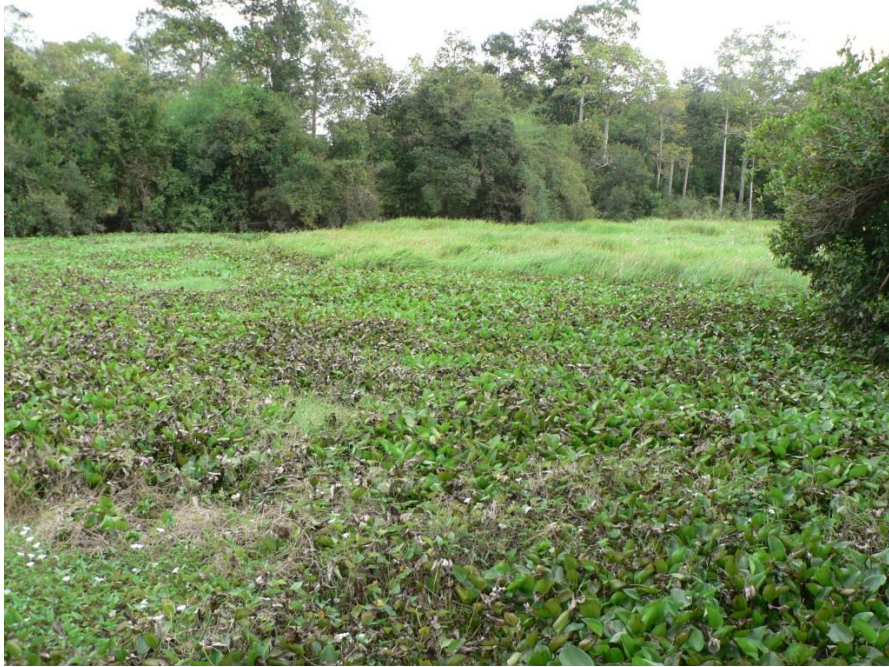
Image B. South facing view of the water hyacinth infestation

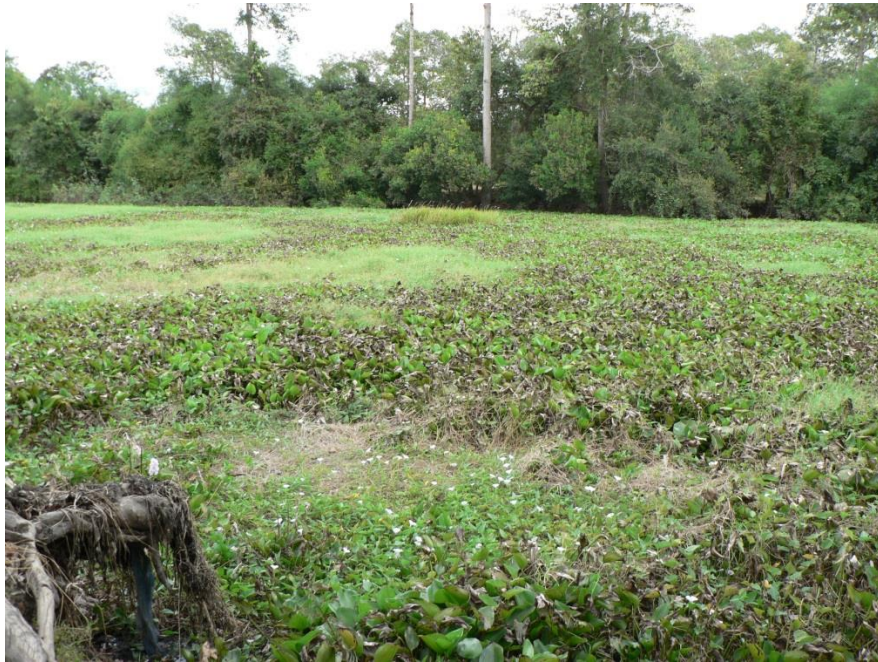
Image C. The width of the management area is approximately 75 metres

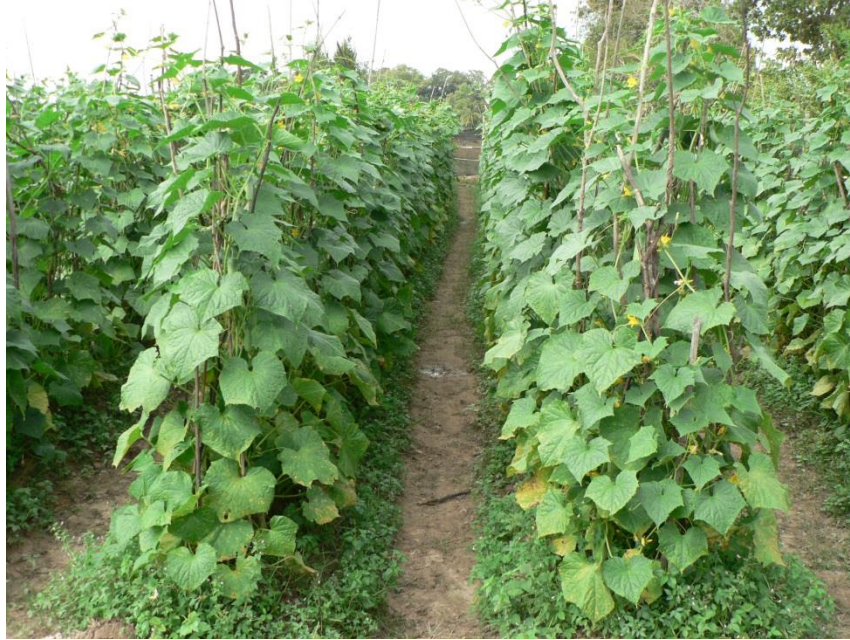
Image D. Decomposed water hyacinth has been used as fertilizer for vegetables

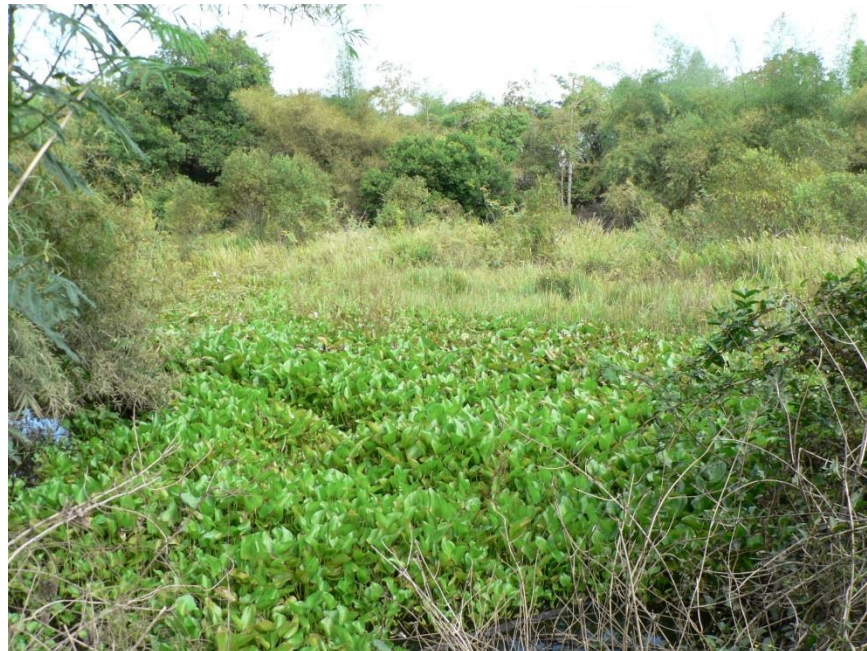
Image B. The first management area, approximately 150 m by 50 m

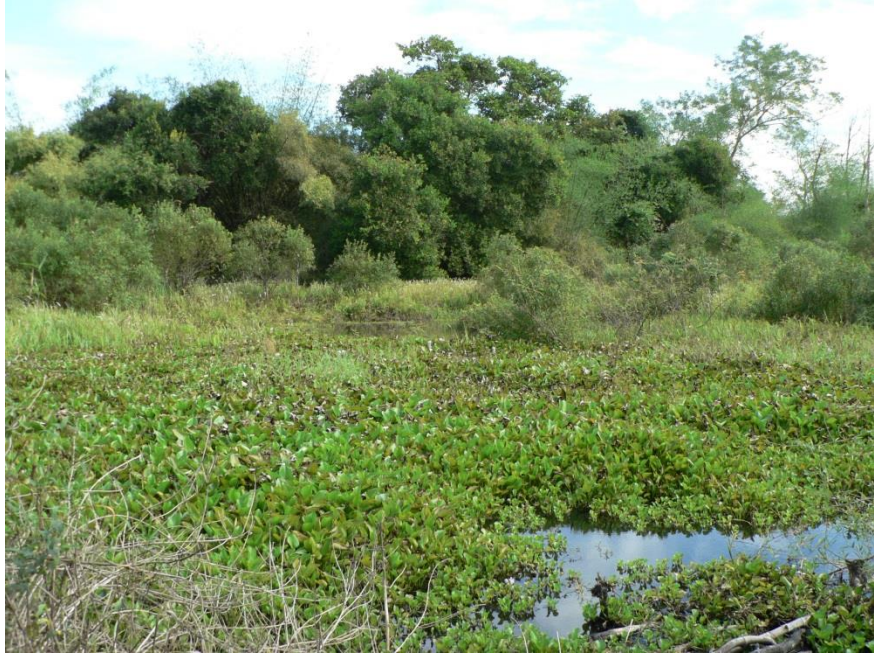
Image C. Northeast view of the first management area of the water hyacinth infestation

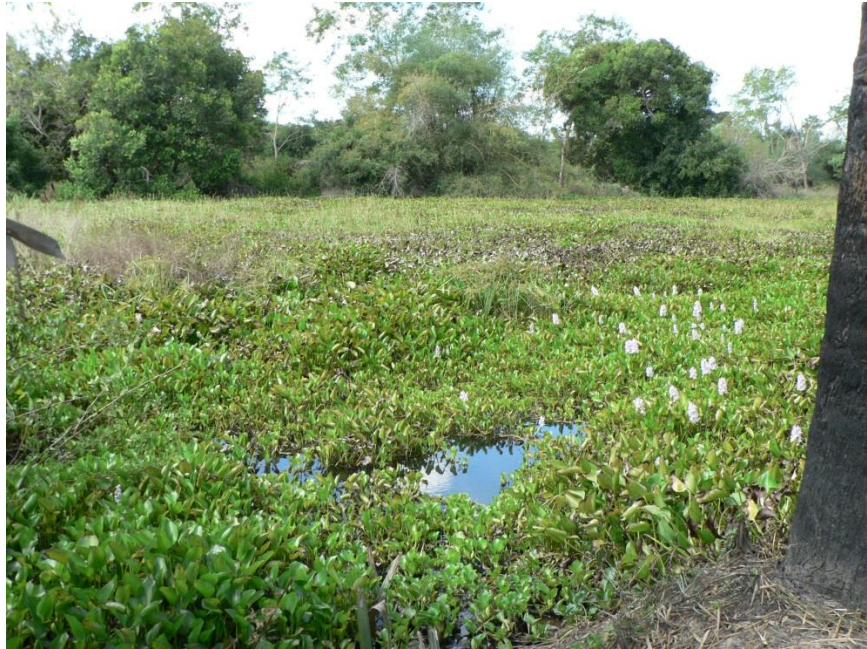
Image D. Start of the second management area

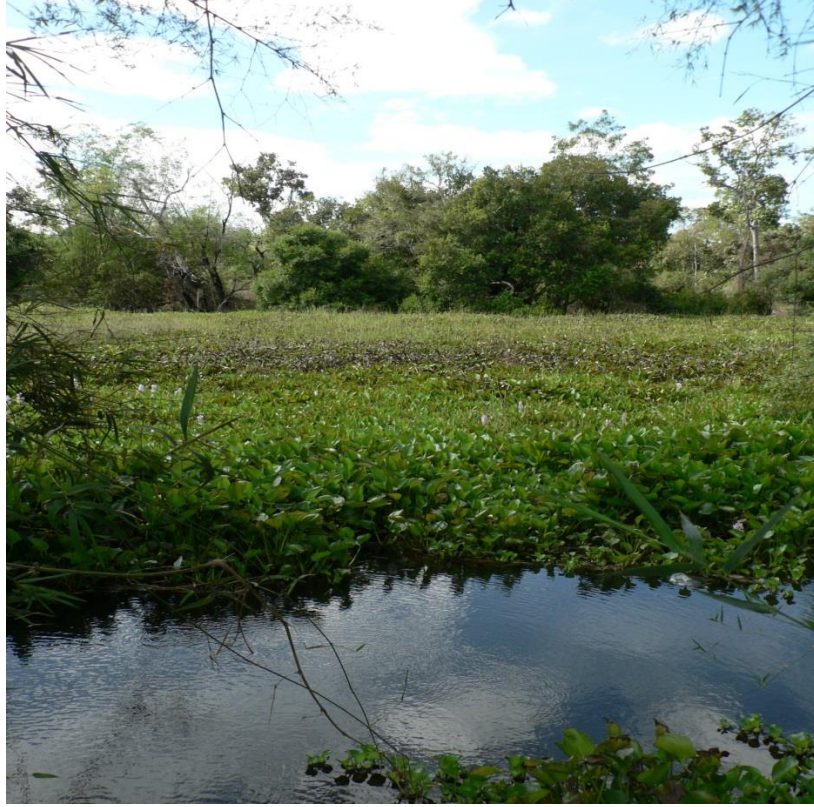
Image E. The second management area is approximately 200 m by 50 m

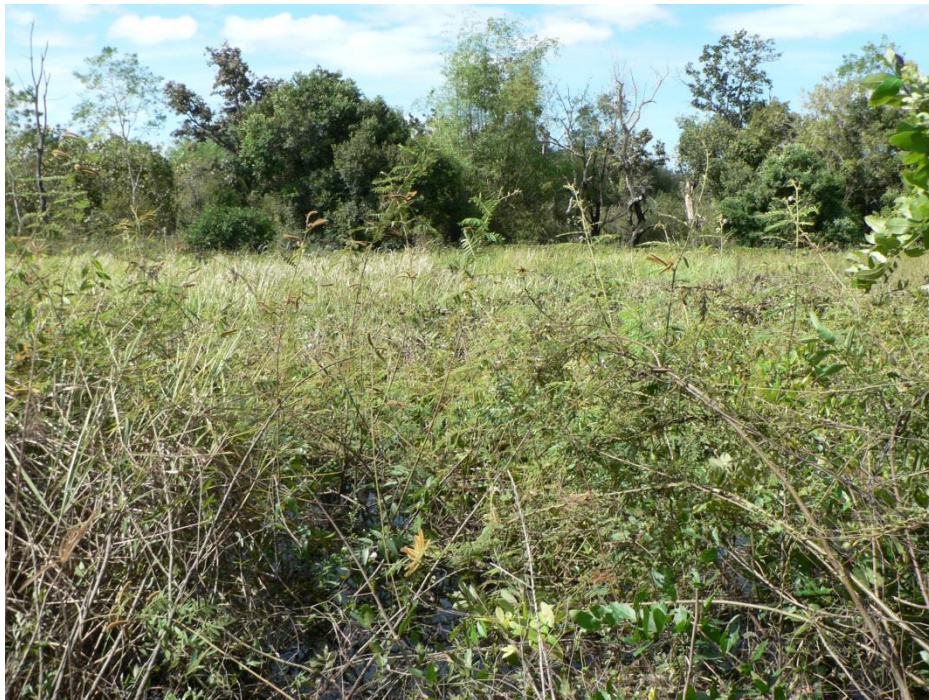
Image F. Recommended are for *Mimosa pigra* removal at the second management site

February and March were identified as the best time for removal by Ban Kadan villagers so that it is carried out before the start of the rice planting season. They recommend that the water hyacinth removal be done once a month to ensure it is properly maintained. For mimosa control in rice fields, villagers often use a mechanical line trimmer to cut stems in May, just before the wet season to allow complete submergence of plants for an extended period. This technique has been used effectively and villagers indicate that after two years of treatment mimosa plants can be killed.

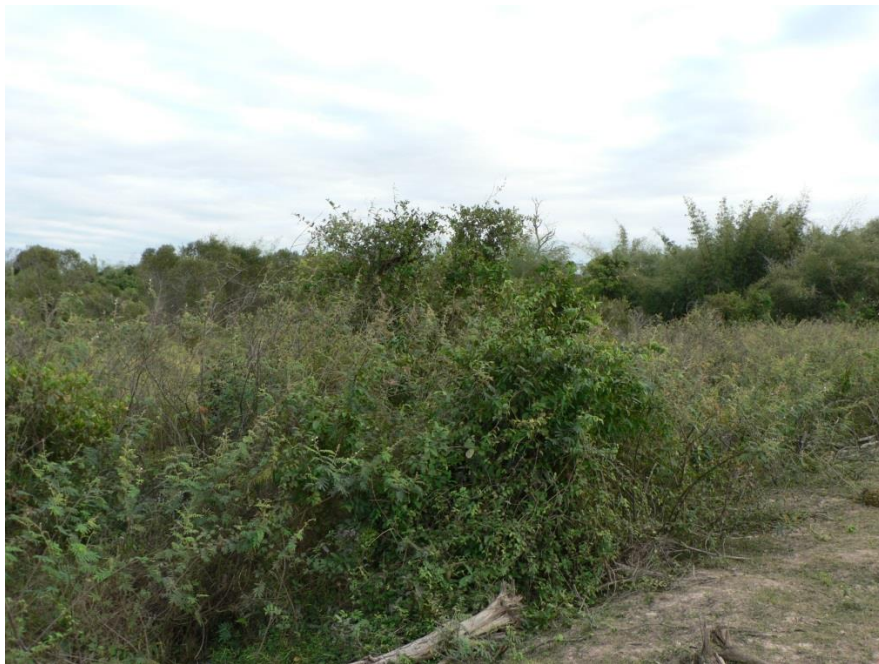
Image B. The management area is approximately 100 m by 30 m

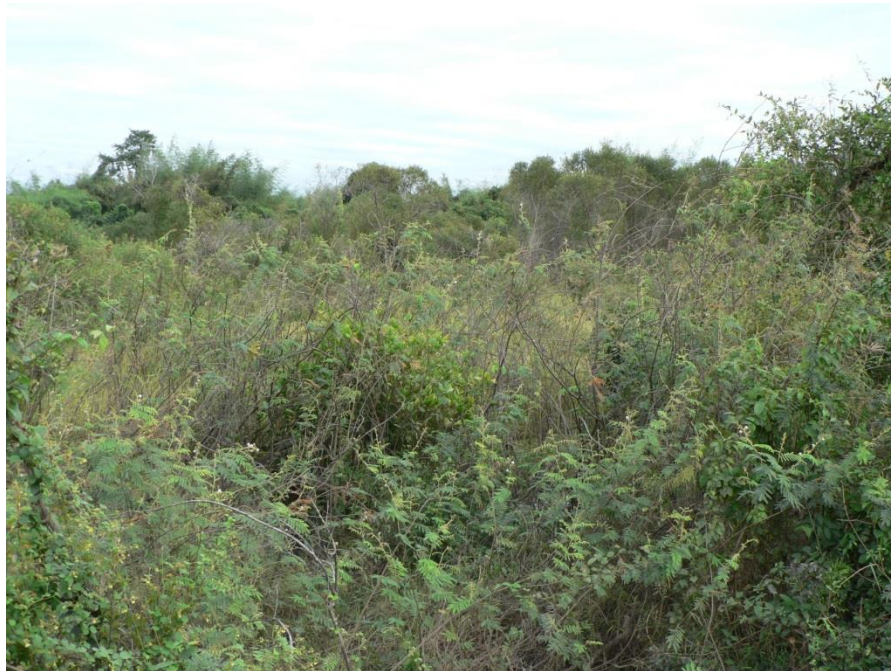
Image C. *Mimosa pigra* along the edge of the management area

The recommended technique for controlling adult plants of *Mimosa pigra* in wetlands is to cut stems of mimosa to the ground, or as close as possible, immediately prior to commencement of the wet season or as water levels are rising (Hout, 2014; Nguyen et al., 2007). Incoming flood waters then inundate the cut stems for an extended period preventing re-growth and the plant can be killed or severely reduced in vigor. As identified, villagers already use this technique effectively in rice fields, and indicate that if this method is repeated over a 2-3 year consecutive period plants are usually killed. It has also been demonstrated as an effective method during a pilot management site set up by FAO in the village of Ban Laonat (Bouan et al 2017).

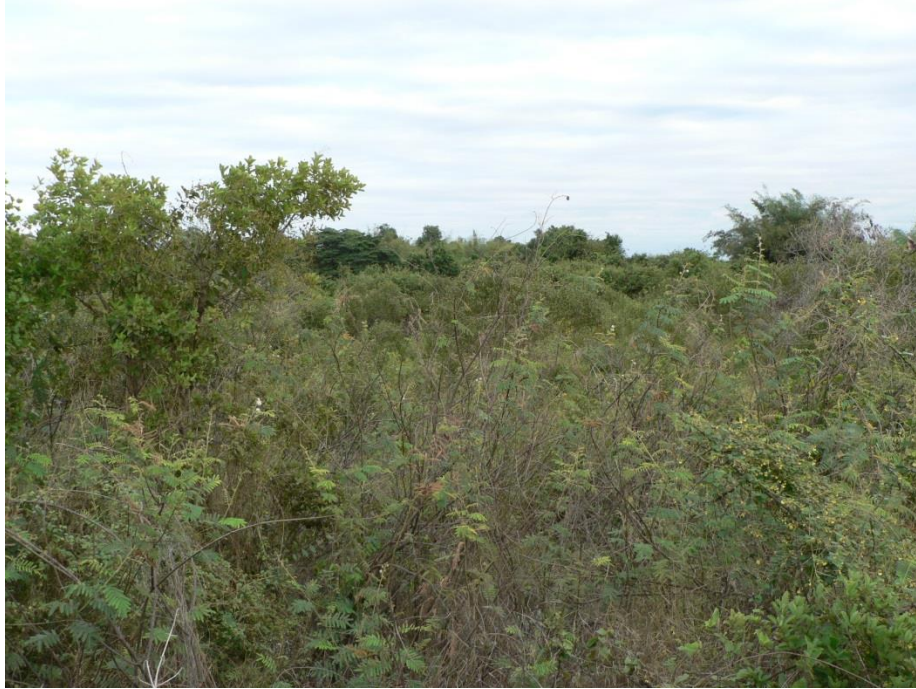
Image D. The spread of *Mimosa pigra* into the oxbow

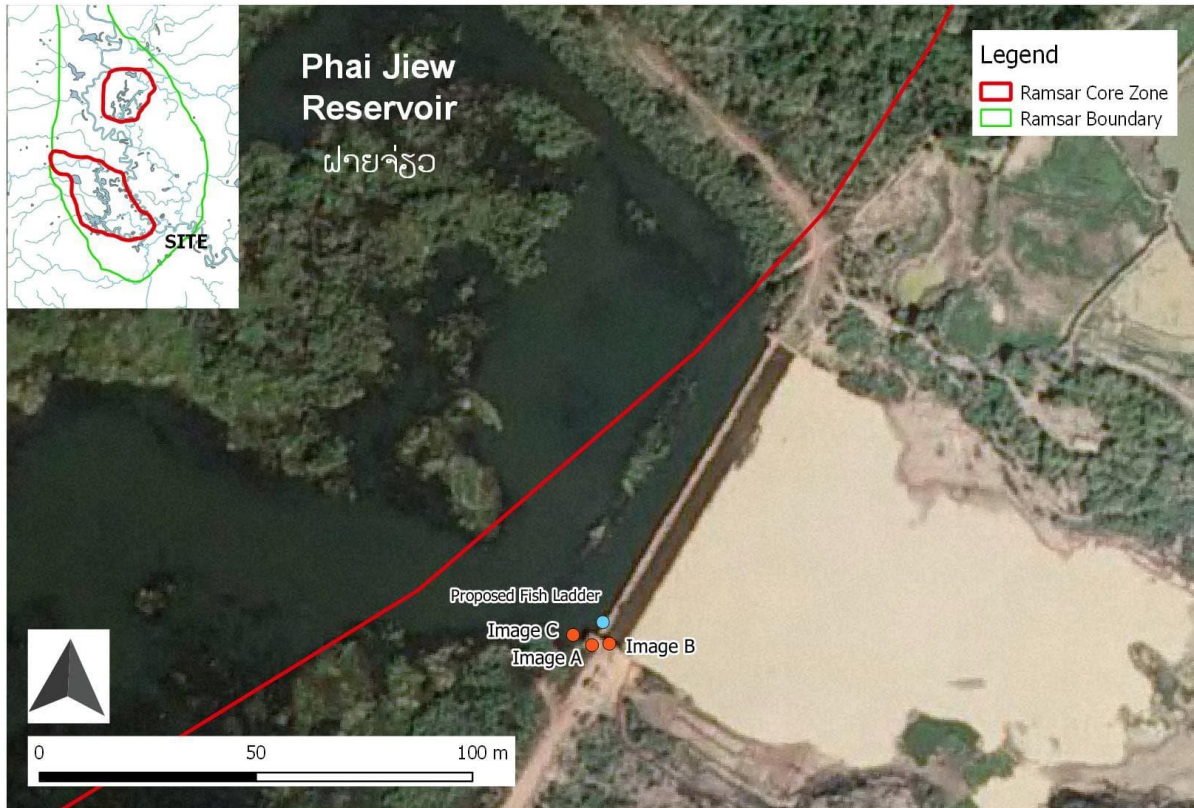
Figure 6. Site 5 Phai Jiew Weir

During June and July, when water is flowing out of the reservoir, fish have been observed by villagers attempting to jump up the weir from the downstream side. The dam and weir appears to be causing disconnection of fish passage, such that the strong water flows during these months inhibit fish from moving over the weir to spawning sites.

A fish way is recommended to aid in fish passage particularly during the early wet season. This will require further investigations in regards to developing fish way designs, planning proposals and confirming funding and feasibility. There is good access to the site for construction purposes, and strong support from local villagers and government DAFO & DoNRE for the project.

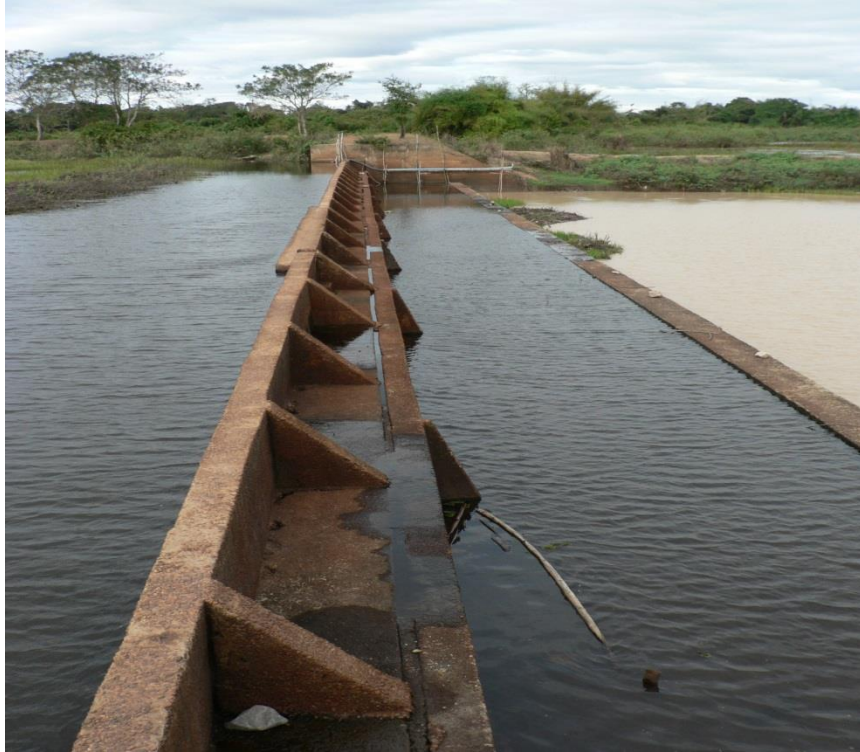
Image A. The dam blocking fish migration

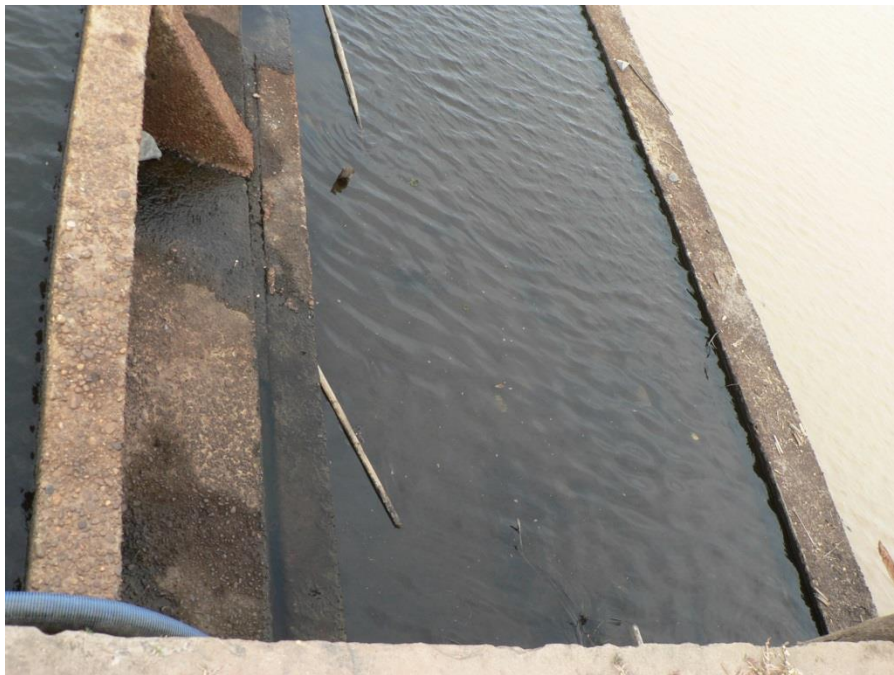
Image B. Proposed area of the dam for the fish ladder

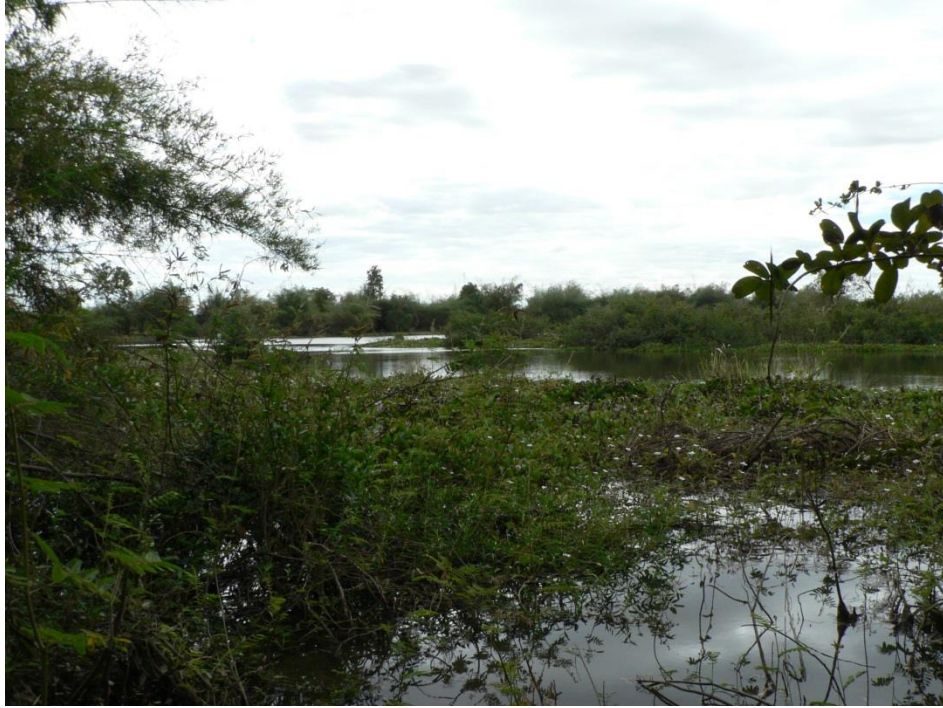
Image B. South-facing view of the narrow channel at Kout Khan 1

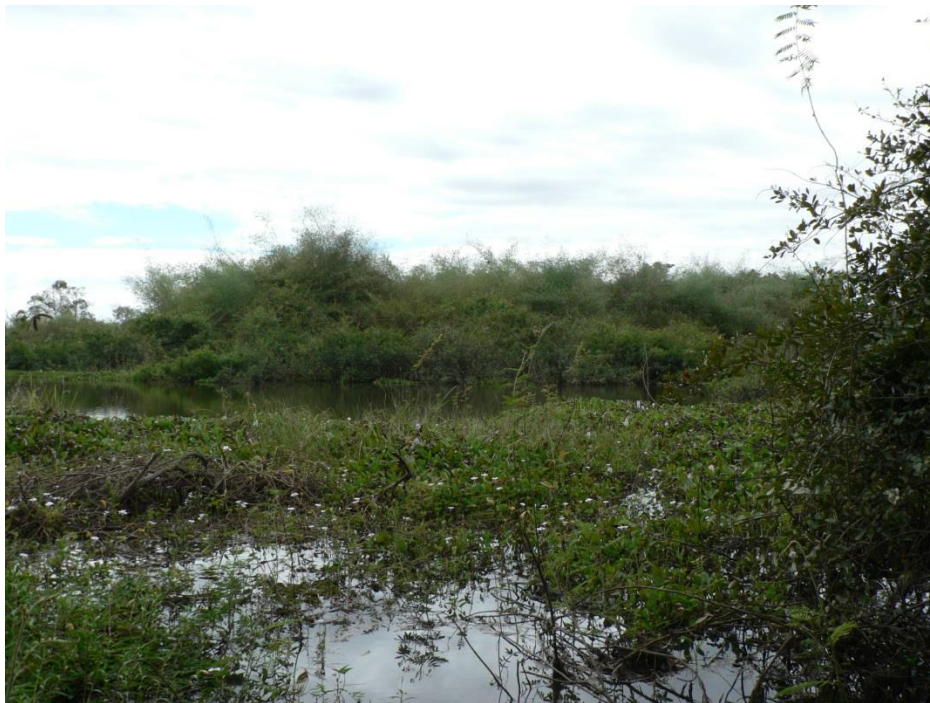
Image C. The management area of Kout Khan 1 is approximately 300 m by 30 m

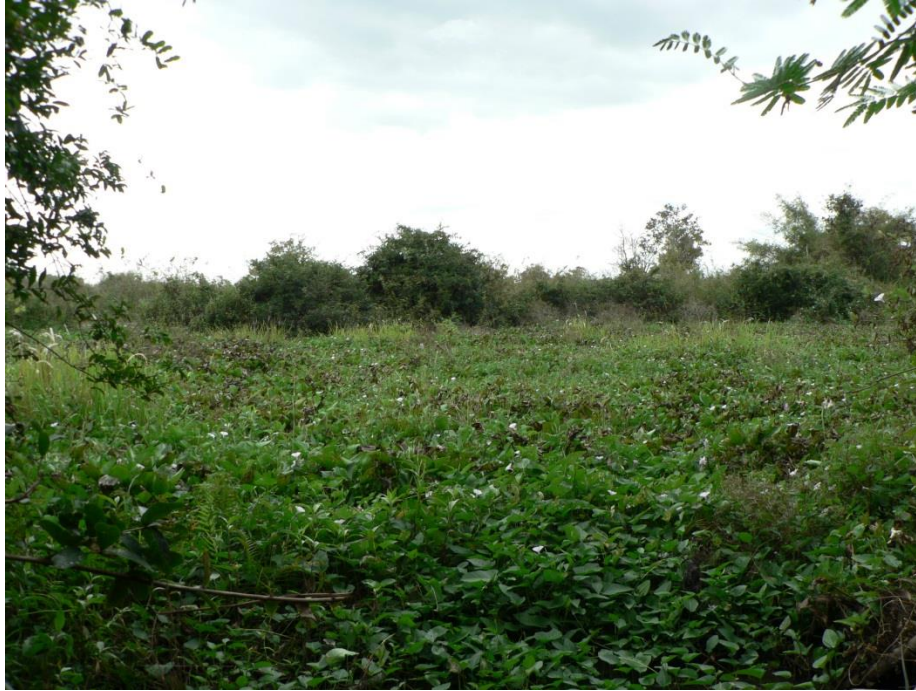
Image D. Dense water hyacinth covers the Kout Khan 2 oxbow

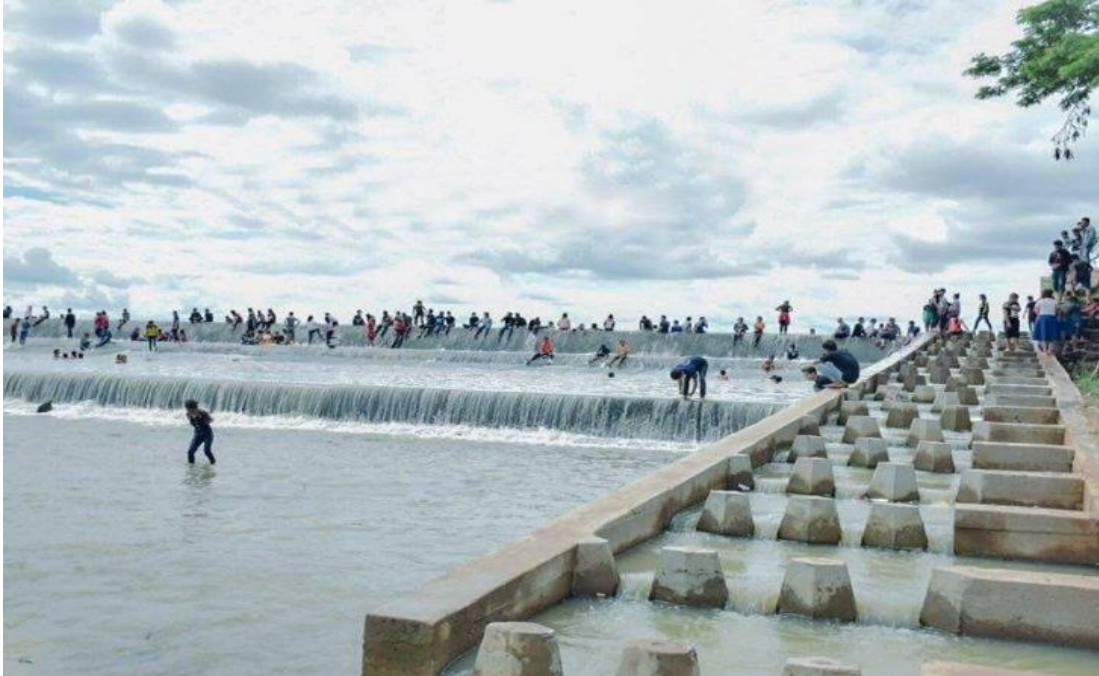
Cone fish-ways are a pre-cast concrete structure designed to allow a broad size range of fish. The cone shaped baffles making up a series of ridges through which fish pass, they are designed to have conservative hydraulics (low velocities & turbulence levels). These fish-ways are most useful where there is limited headwater variation and relatively low (<1.5 m) head differential. This is the fish-way design constructed at Souy Weir and as it's already a design previously identified as feasible for the XCP site, it may be a possible option. However, the Phai Jiew context, particularly height differences, will need to be further assessed.

Figure 9: Cone design fish-way, Souy Weir (photo taken shortly after public opening) (A. O'Brien)

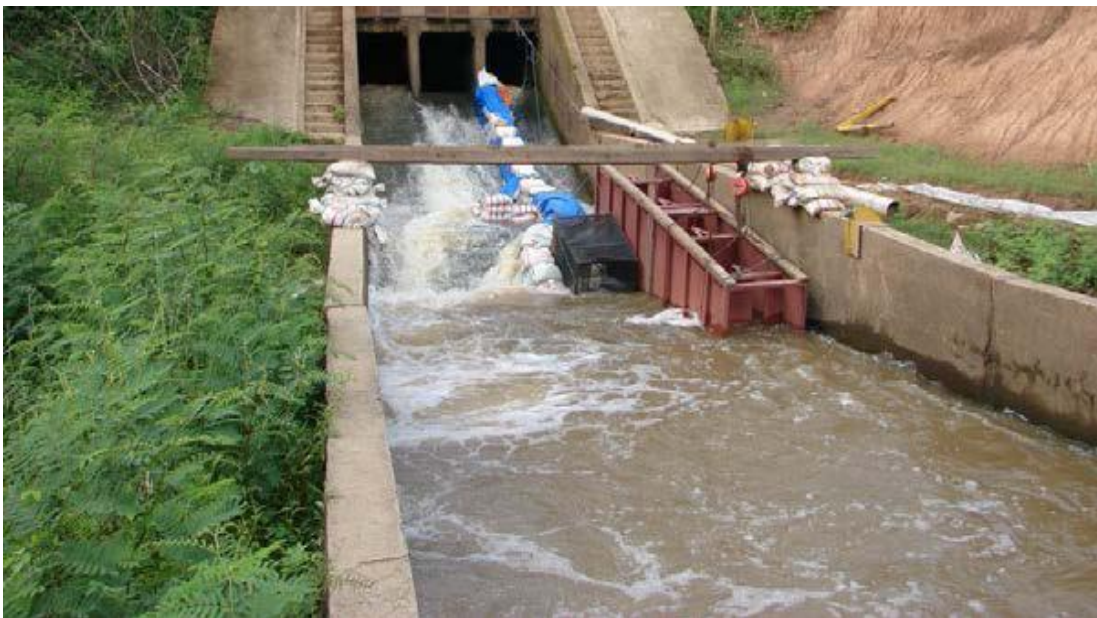
Lessons of small fishway infrastructure implementation can be taken from the research done for the Pak Peung wetland area in Bolikamaxay Province, Lao PDR in 2008-2009. Similar to Phai Jiew, a 10 metre high concrete regulator blocks upstream migration. The process used to determine appropriate fish passage at Pak Peung was to: (i) Identify the migratory fish community; (ii) Test fish in a temporary experimental fishway; (iii) Design and build the fishway; and (iv) Assess the fishway (Baumgartner et al., 2012). A similar process could be implemented to determine the most appropriate fishway structure for Phai Jiew Weir.

Figure11: Pak Peung Regulator with submerged temporary experimental orifice fishway for fish counting (Singhanouvong et al., 2015)
